Immediate Anterior Zirconia Implant: three years follow-up

High-Tech Aesthetics

Rami Sarkis, DDS, MSc, Beirut/Lebanon

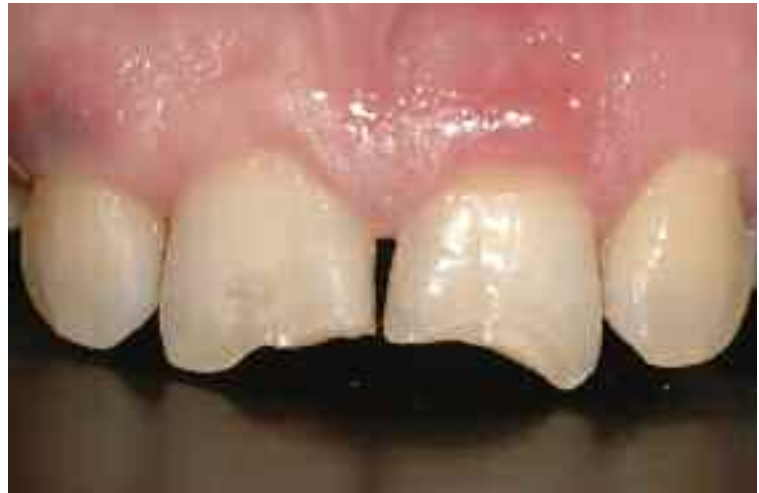
Fig. 1 The traumatized upper left central incisors 21 and 11.

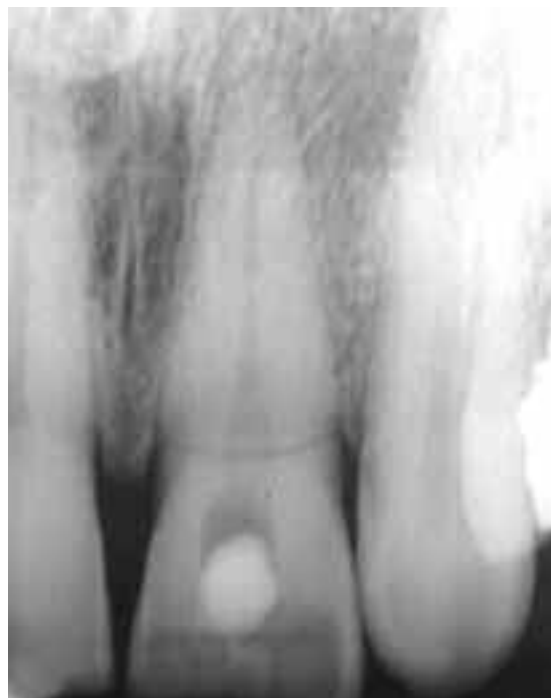
Fig. 2 A horizontal root-level fracture on tooth 21 was detected.

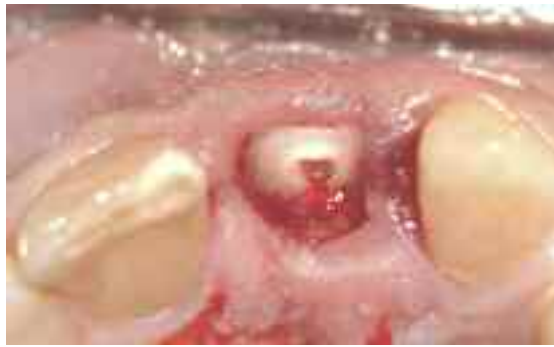
Fig. 3 Root of tooth 21 scheduled for extraction.

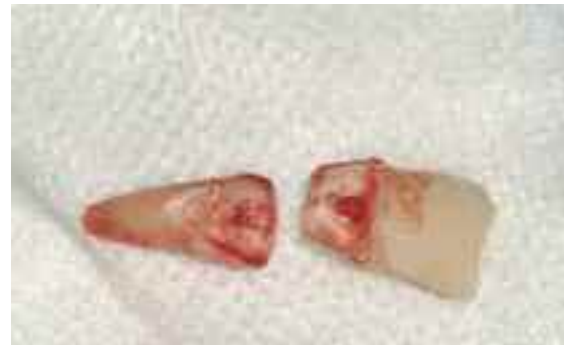
Fig. 4 Careful extraction of the remaining part of the root.

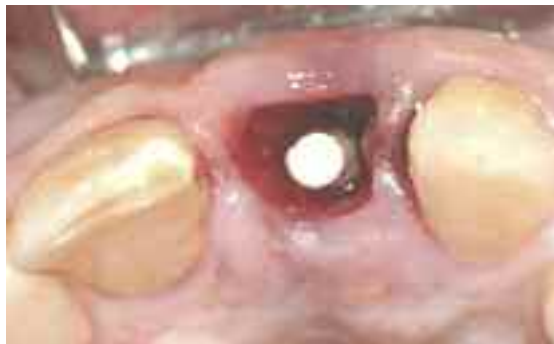
Fig. 5 The alveolar socket was large. No socket defect and no loss of buccal bone were observed. The direction of the preparation was moved toward the palatal side following the golden preparation rules for immediate implant placement.

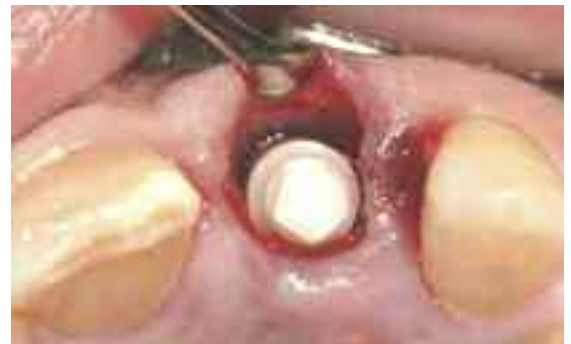
Fig. 6 An immediate 3Y-TZP zirconia dental implant (zit-z, ziterion, 13 mm long, 4 mm in diameter) was inserted in the prepared site at a torque of 35 N.

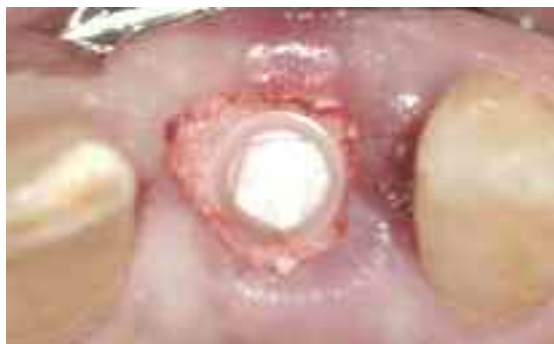
Fig. 7 The remaining bone defect was filled with a bone replacement material (Bio-Oss, Geistlich). The biomaterial was overfilled to the most coronal part of the polished neck of the implant. No protective membrane was used in this clinical situation.

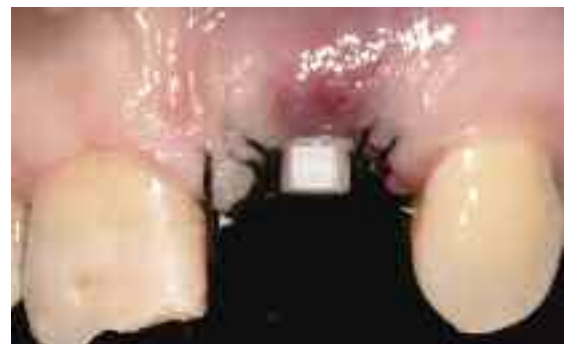
Fig. 8 The mucosa was carefully fitted around the neck of the implant using sutures, which were removed after ten days.

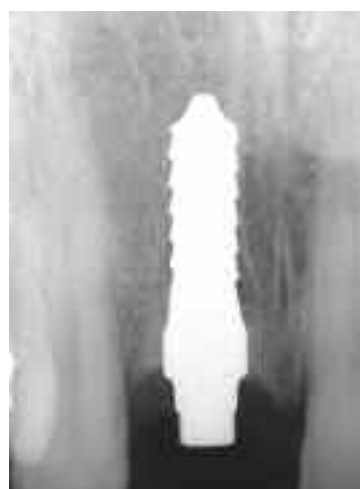
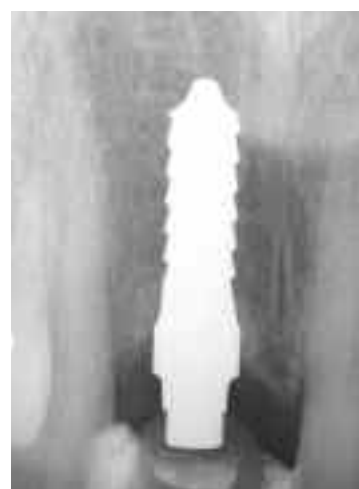
Fig. 9 Radiographs were taken immediately after implant placement. Note the condensed biomaterials at the coronal aspect and the bone morphology at the mid-apical aspect of the implant. The crown of the extracted tooth was modified to serve as a provisional restoration protecting the implant during the healing period.

Fig. 10 Radiograph at six months. Note the perfect bone healing in the mid-apical part. With one-piece implants, special care must be taken to avoid premature loading.

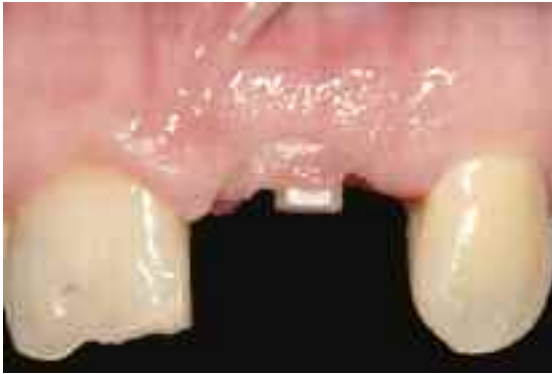
Fig. 11 The implant has a highly polished neck of 1.5 mm, allowing a tight connection of the circular collagen fibres and epithelium of the mucosa. Note the creeping attachment on the zirconia surface, which confirms the findings of several studies about the excellent affinity of the soft tissue and a certain degree of direct attachment to a zirconia surface.

structures appear capable of withstanding occlusal forces over a long period. The zit-z implant design is based on a one-piece toughened zirconia implant. The implant is transmucosal and therefore exposed to the oral cavity immediately after placement. This necessitates special attention to prevent occlusal loads during the healing period in order to protect the bone apposition process to the implant surface.

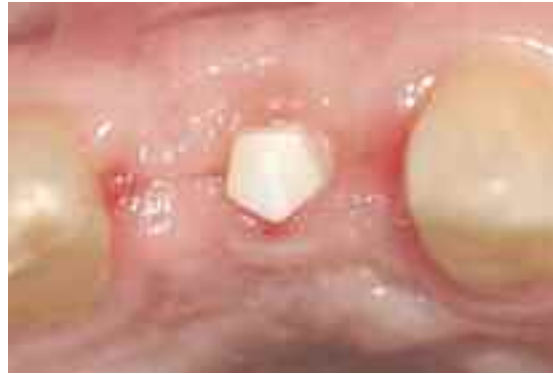
Fig. 12 Occlusal view of the pentagonal connector of a zit-z zirconia implant six months after implant placement.

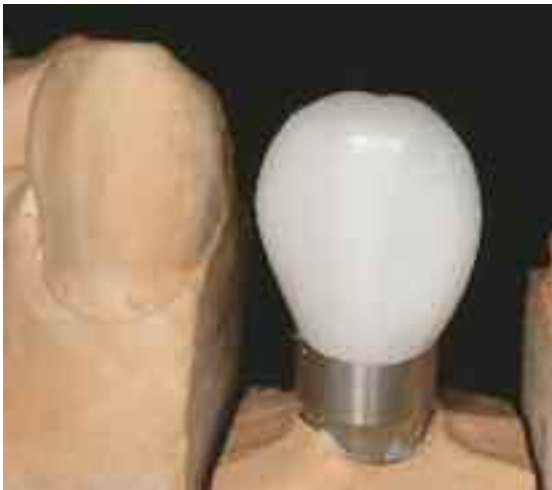
Fig. 13 A conventional impression of the implant (open tray technique) was taken. A CAD/CAM zirconia framework (Pro-cera, Nobel Biocare, Göteborg, Sweden) was checked against the implant replica to evaluate its fit and marginal integrity.

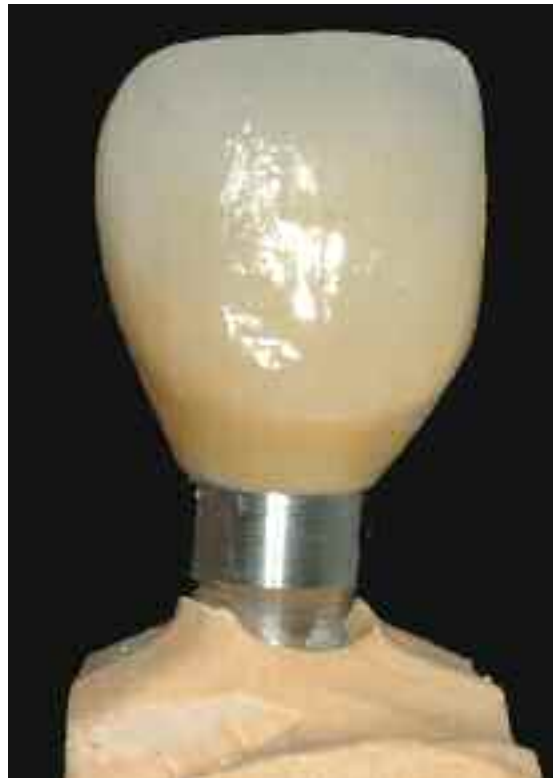
Fig. 15 Ceramic build-up layering and final zirconia crown.

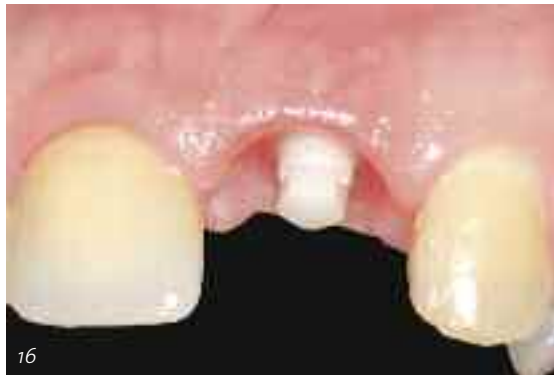
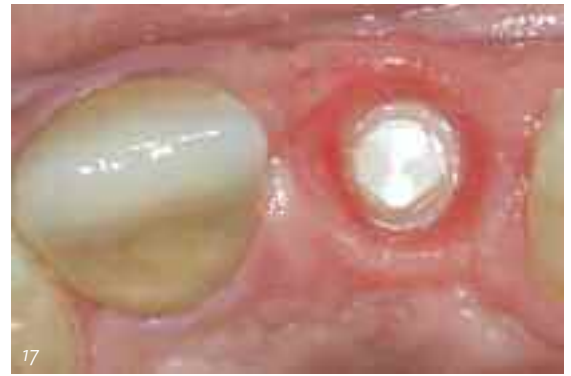
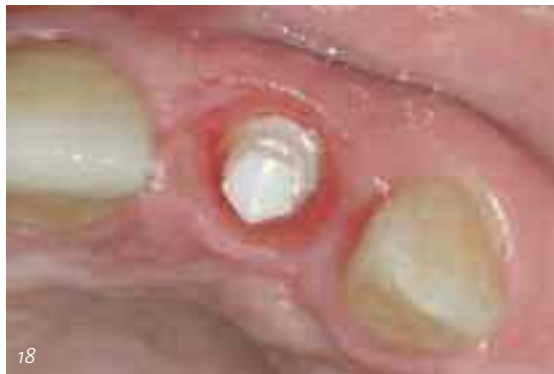
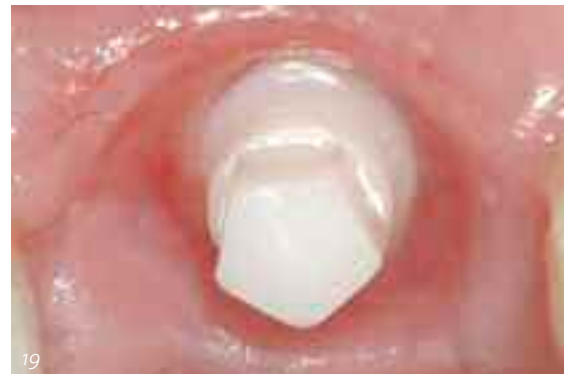
Figs. 16 to 19 Pink aesthetics and emergence profile: The colour of the overlaying oral mucosa is an “ideal pink”. The highly polished ceramic surface of the transmucosal part of the zirconia implant (coronal part of the abutment) contributes toward a healthy gingival margin. The ideal placement of the implant palatally to the adjacent teeth and the perfect vertical and horizontal position of the implant’s prosthetic neck work in favour of soft-tissue healing and an ideal emergence profile – both aesthetic prerequisites.

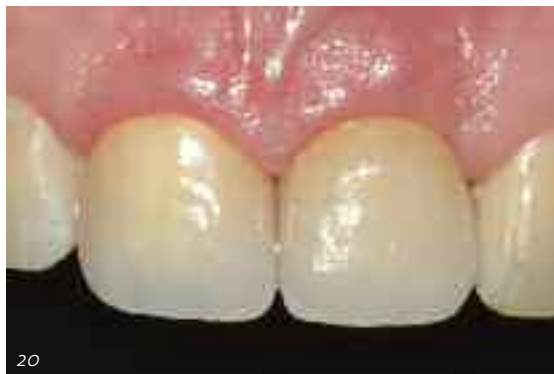
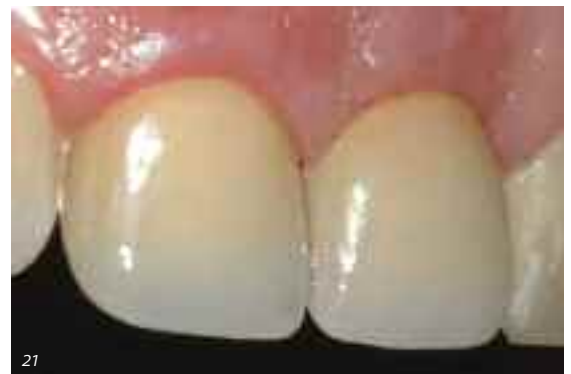
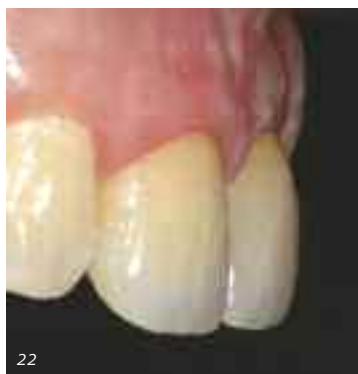
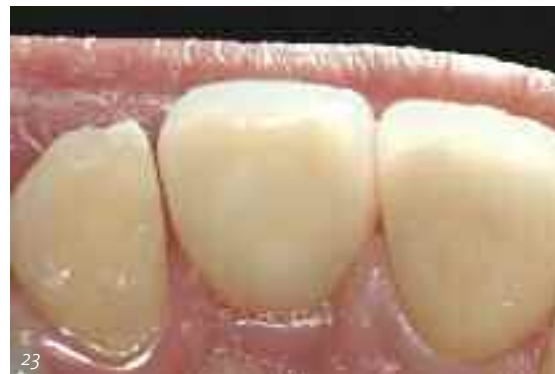
Figs. 20 to 23 An excellent aesthetic and functional result was achieved with the zirconia crown. No clinically discernible bone resorption or soft-tissue recession was observed after two years.

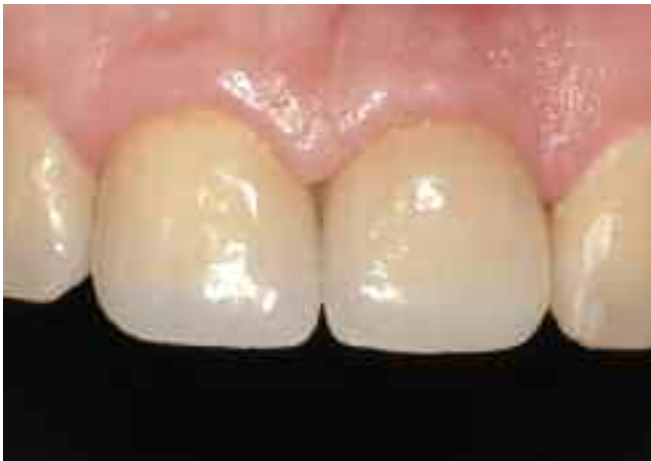
Fig. 25 Clinical situation at three years follow-up.

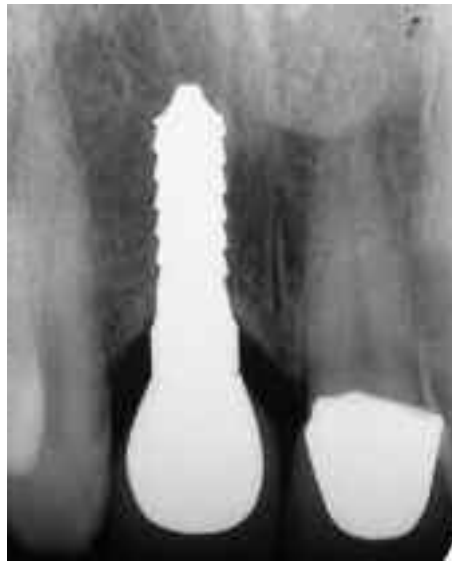
Fig. 26 Radiographic examination at three years follow-up. Bone stability directly at the 1.5 mm polished neck limit.
